PRODUCT BULLETIN CR2510

RADIATOR

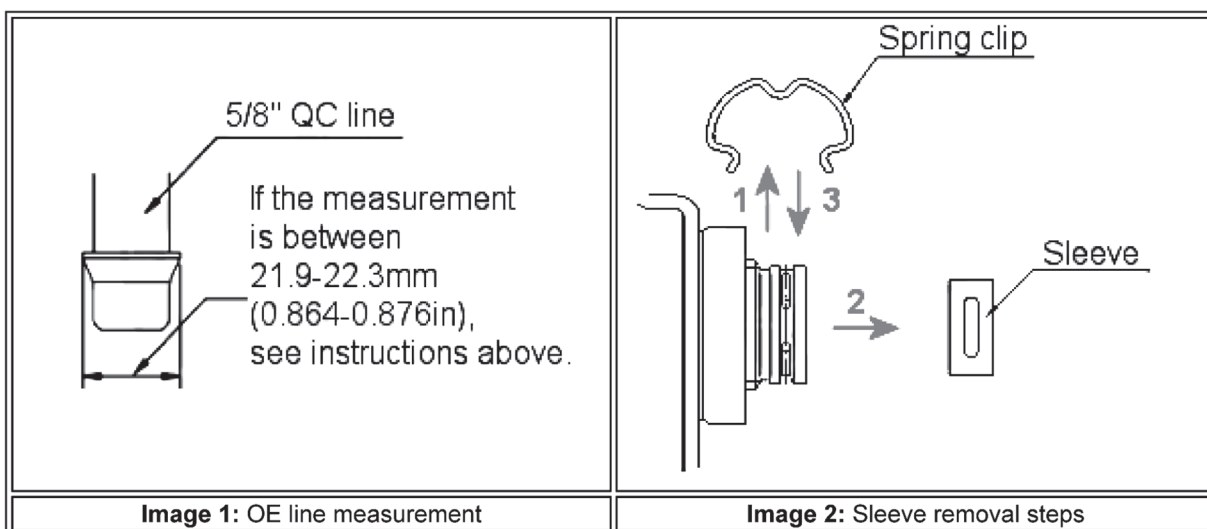
The transmission oil cooler (TOC) fittings (located on the passenger-side tank) on your new radiator may require modification if the lines will not install into the fitting or the diameter at the widest point of the flared end of lines measures 21.9-22.3mm (0.864-0.876in) [Image 1]. In order to allow the lines on your vehicle to install into the fitting you will need to remove the fitting sleeve as follows [Image 2]:

1. Remove the spring clip from the fitting using a pick or pointed tool by gently prying one end out of the fitting and rotating the spring away from the fitting. Take care to not damage it. Save this clip as it will need to be reinstalled later.
2. Slide the sleeve out of the fitting.
3. Reinstall the spring clip in reverse of how it was removed.
4. Install the line in the fitting. Listen for a "click" (indicating the spring clip has snapped behind the flare on the line).
5. Check that line is secure in the fitting and can not be pulled out.
6. Repeat for the other fitting and check for leaks.
